UNITED STATES AIR FORCE
AIRCRAFT ACCIDENT INVESTIGATION
BOARD REPORT

A-29B, T/N 13-2015

**81ST FIGHTER SQUADRON
14TH FLYING TRAINING WING
MOODY AIR FORCE BASE, GEORGIA**

DATE OF ACCIDENT: 6 MARCH 2017

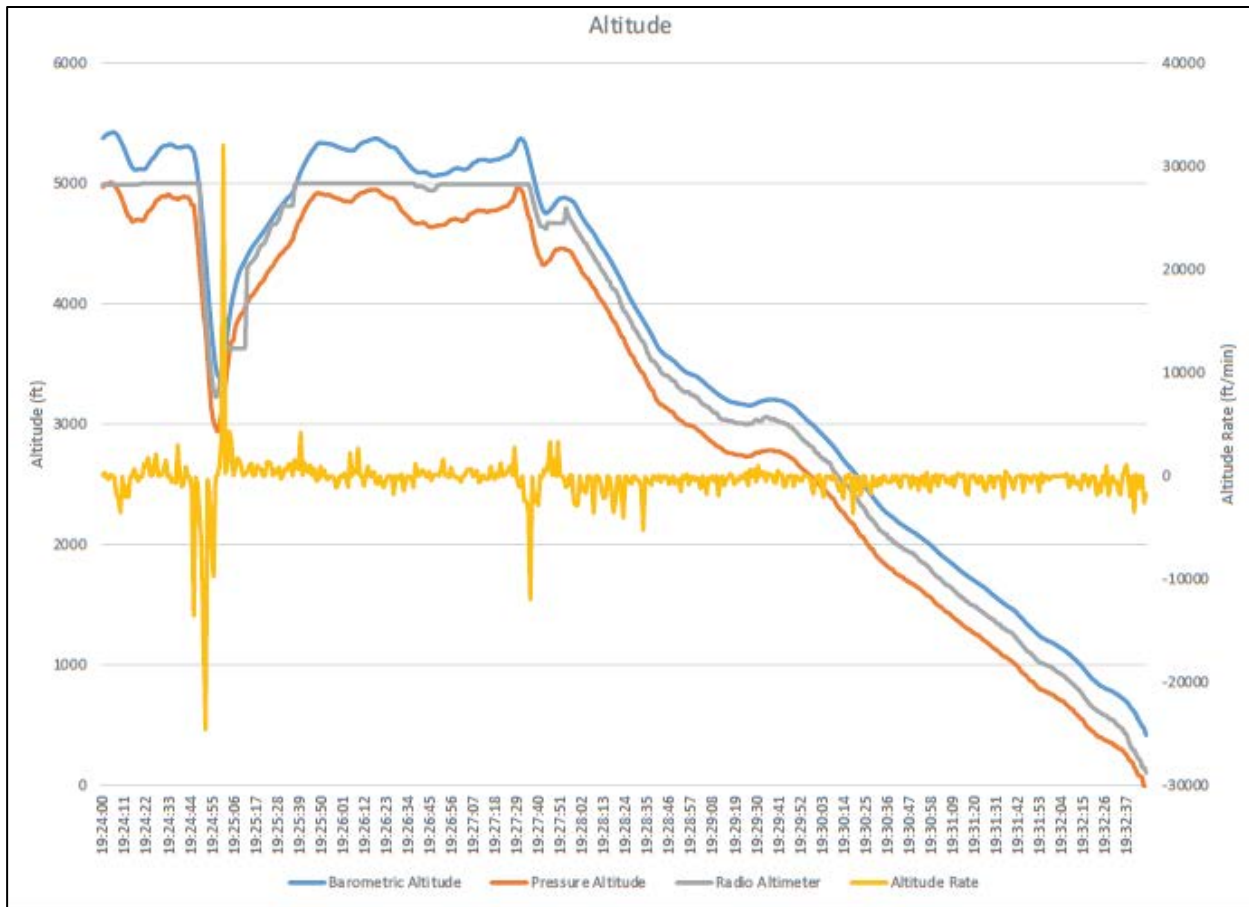
Tab AA-7

Based on data recorded onboard the aircraft, just prior to 19:27:22Z the MA was maneuvering at approximately 160 KCAS, 5,000' MSL and 50% torque when propeller RPM rapidly dropped with a corresponding increase in torque (Tab AA-6). Engine oil pressure increased steadily throughout the event and eventually stabilized above the acceptable range (Tab AA-6). Thrust deteriorated to the point where the aircraft could no longer maintain sufficient speed and altitude to recover at MAFB (Tab AA-6).

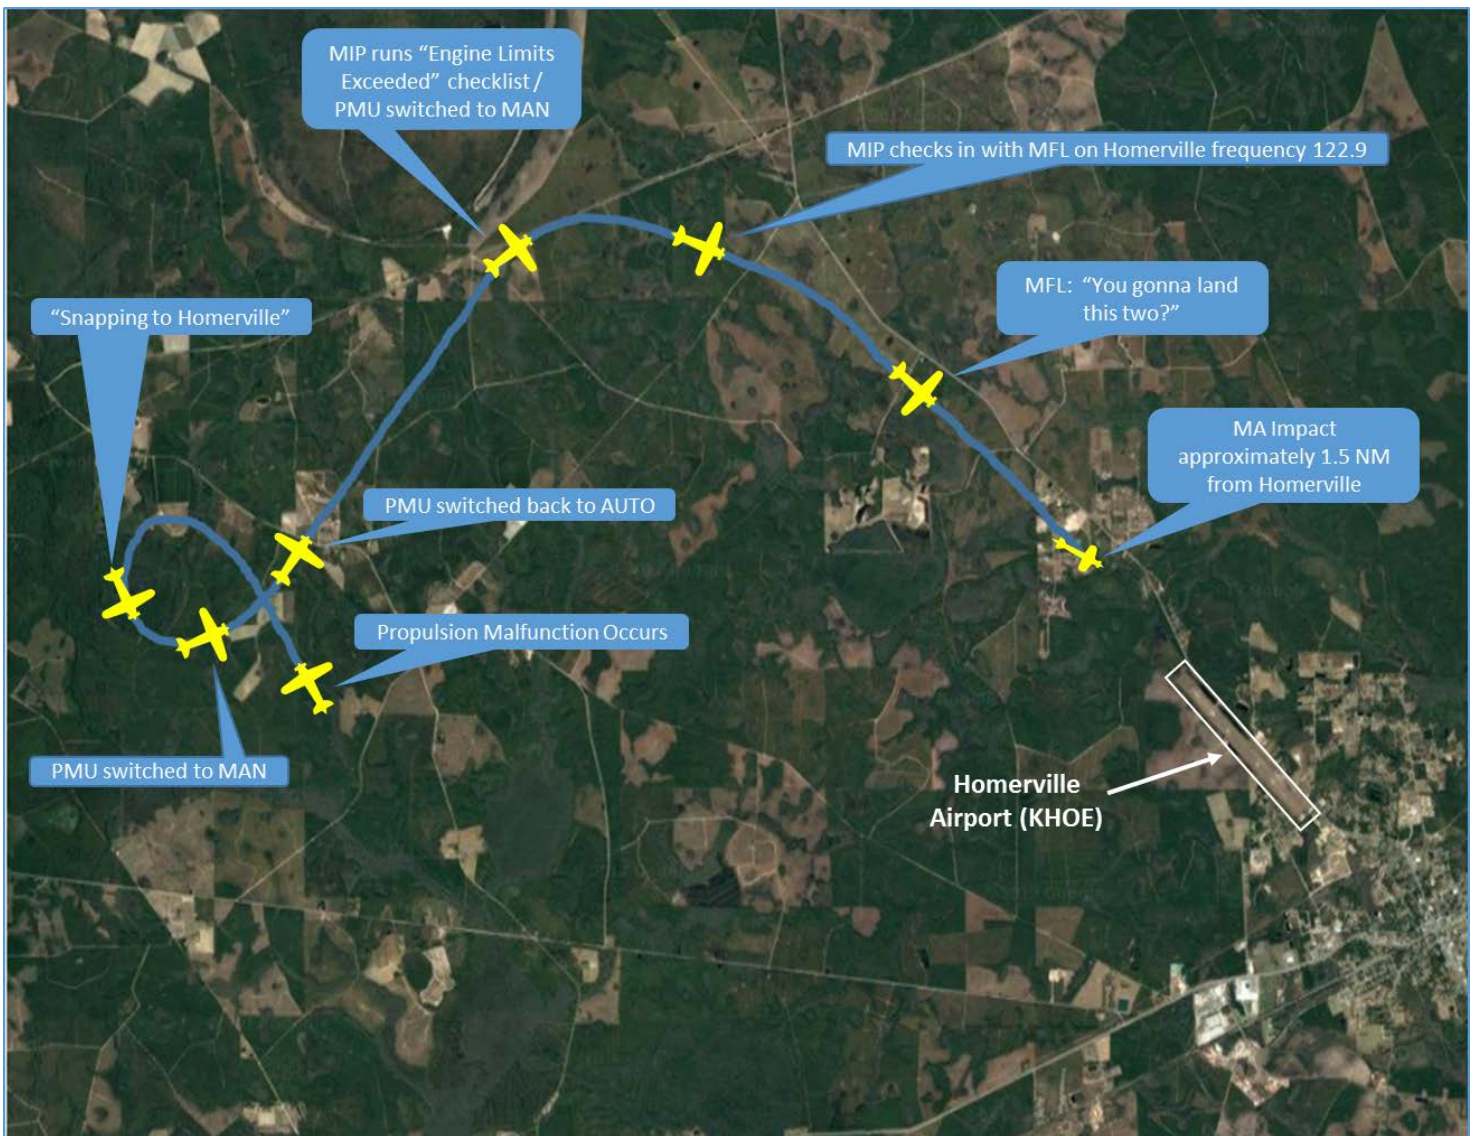
Tab AA-4

At 19:32:48Z, the MA crashed approximately 1.5 miles northwest of KHOE at an elevation of approximately 200 feet MSL (Tab AA-4 and AA-14). The MA was configured with two external fuel tanks on stations two and four (Tab V-2.2). The MA struck trees on the way down and impacted the ground at an approximate 133° magnetic heading (Tab AA-3). The MA struck the ground in approximately 60° of left bank, with a pitch attitude 30° nose low at 100 KCAS (Tab AA-3). The MA came to rest after striking a tree approximately 75 feet from the impact site and was mostly intact with the exception of the tail section and a portion of the right wing, both of which separated from the main aircraft during its descent and impact (Tab S-4 and S-9 to S-10).

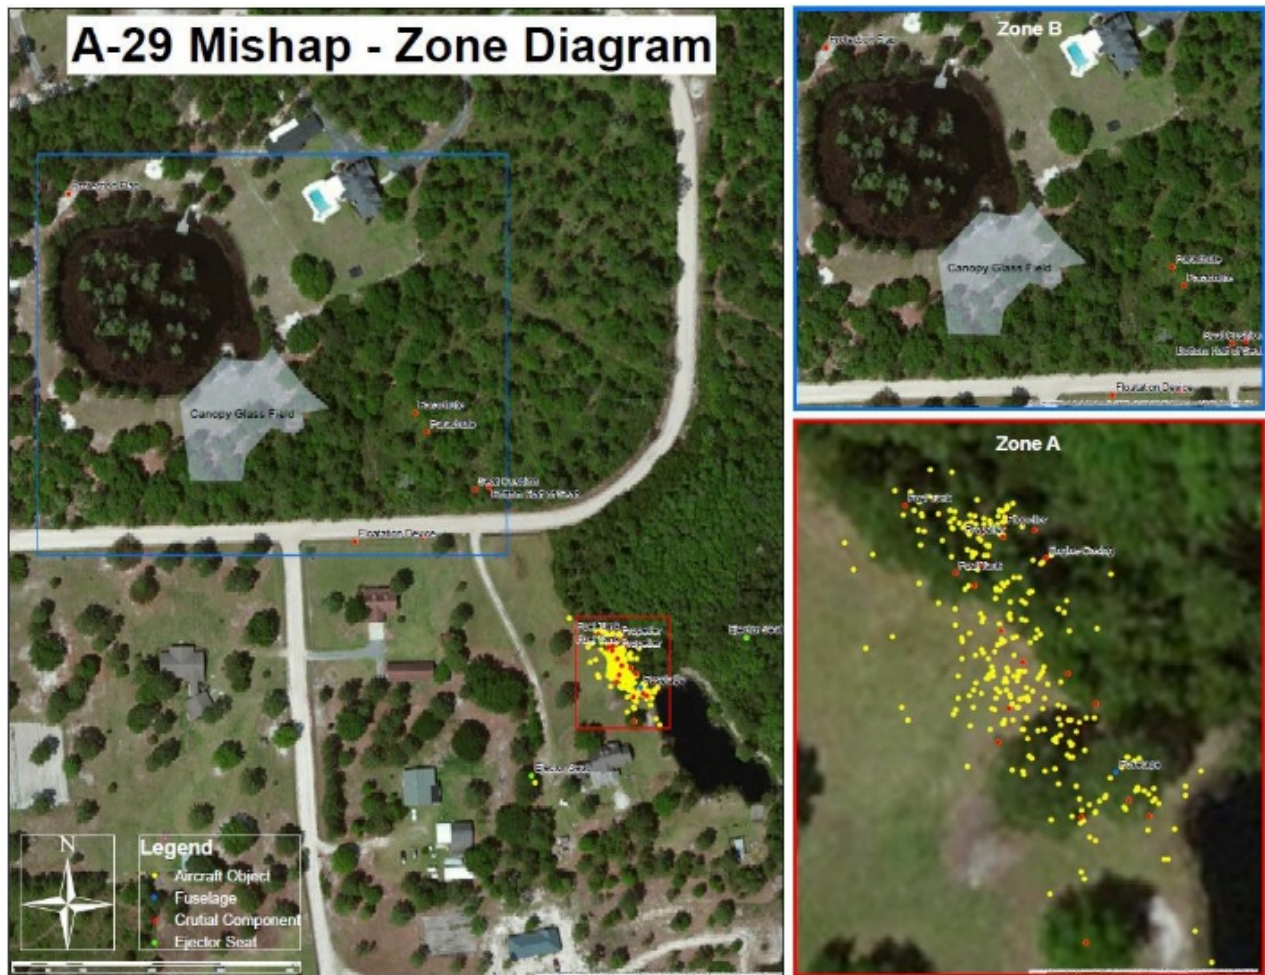
Tab S-15

The MIP and MSP landed in trees approximately 420 feet from the main impact site (Tab S-3 and S-15). The MIP released his harness, dropped approximately 4 feet to the ground, and then assisted the MSP who was about 20-30 feet away in a tree about 20 feet above the ground (Tabs H-20, R-13, and V-2.3). Local responders and civilians arrived and began assisting within five minutes of the crash (Tabs R-115 and V-2.3). The MIP and MSP were transported to the local hospital in Homerville, GA (Tabs R-13 to R-14, and V-2.3). The MIP sustained compression fracture of the spine during ejection, and the MSP sustained minor injuries (Tab X-2).
